Office of River Protection

HANFORD SITE

Tank AY-102 Status

September 7, 2012

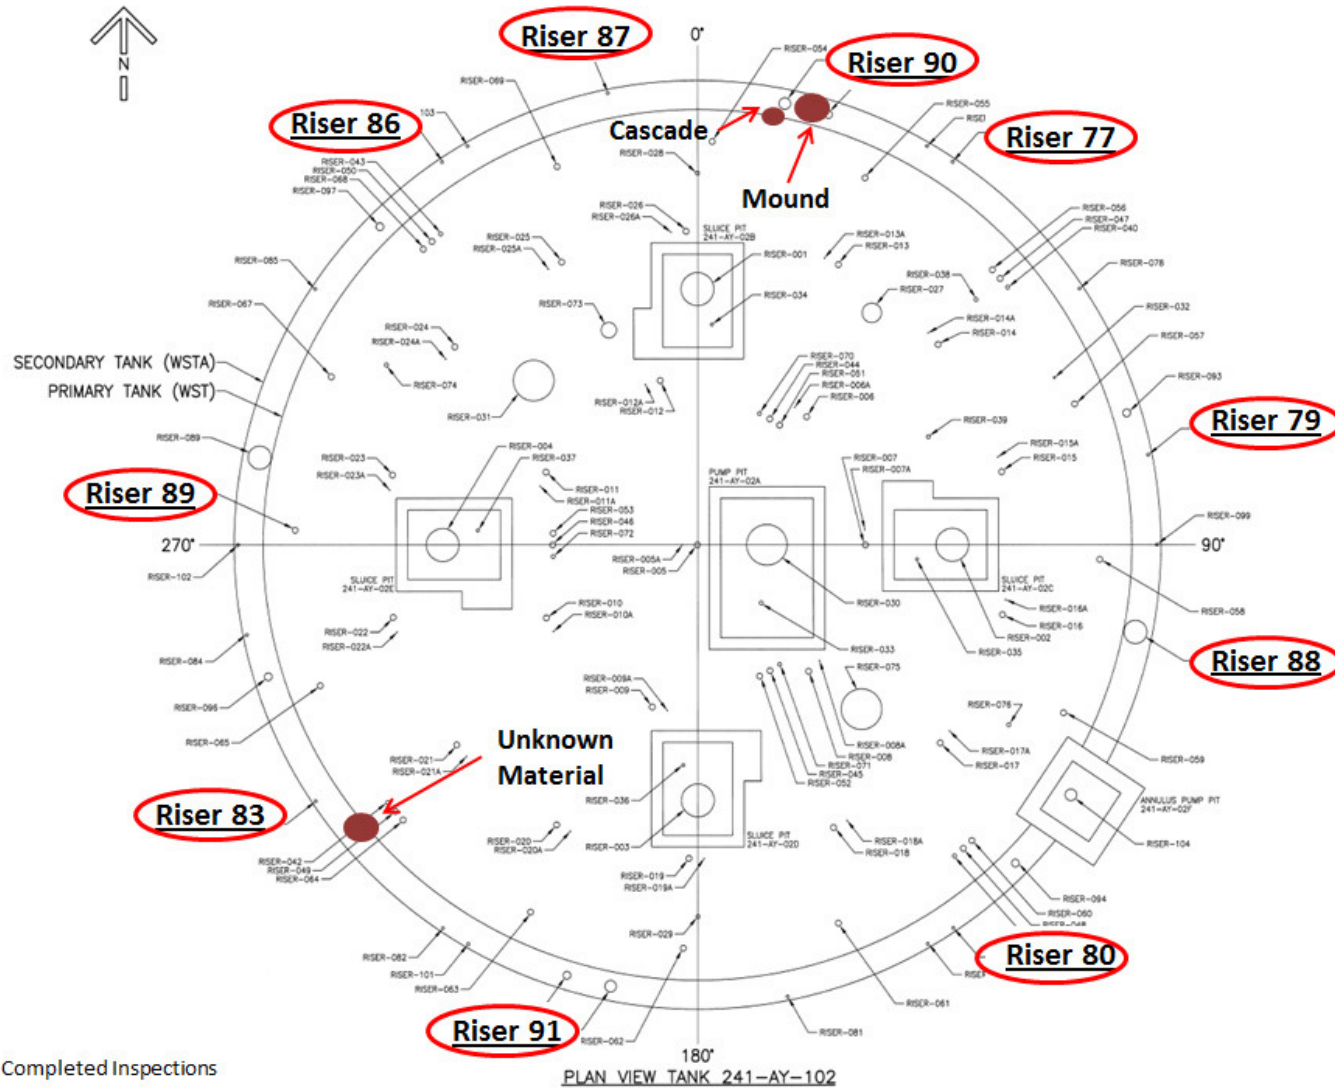
Inspection Photographs from Riser 90 – August 10, 2012

- Material found in three locations (risers 83 & 90) – source unknown
 - Dark brown mound (approximately 2 ft. x 3 ft. x 8 inches) – riser 90
 - White material on both the refractory (tank sits on refractory) and annulus floor – riser 90
 - Unknown material adjacent to ring – riser 83
- Material is dry (i.e., no standing water or indications of moisture)
- Leak Detection and Continuous Air Monitor (CAM) operable in annulus (real time monitoring)
- Camera equipment removed from annulus without incident (i.e., no contamination on equipment)
- Contamination present when annulus floor sample was taken from riser 90
